TECHNICAL MEMORANDUM

Field Reconnaissance of Hanna Stope

July 22, 1999

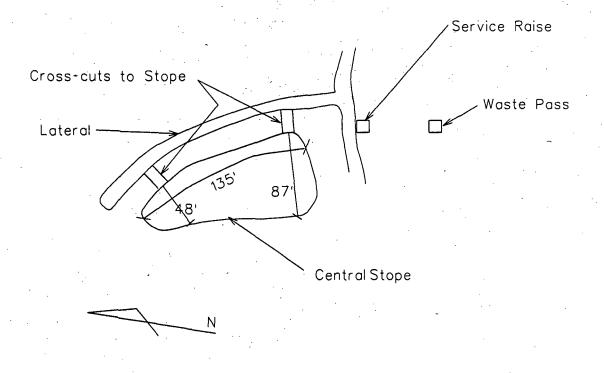
Second Sublevel Below 2 Level

As shown in Figure 4, measurements taken of the central stope area at the second sublevel below 2 Level indicated that the stope was about 135 feet long and was

oriented in a northwest-southeast direction. The width varied from about 90 feet wide at the southeast end to about 50 feet wide at the northwest end of the stope. The average width was approximately 65 feet. This central stope area was found to open both upward and downward at this level. See Figures 7 and 8 for the approximate position and orientation of the stope.

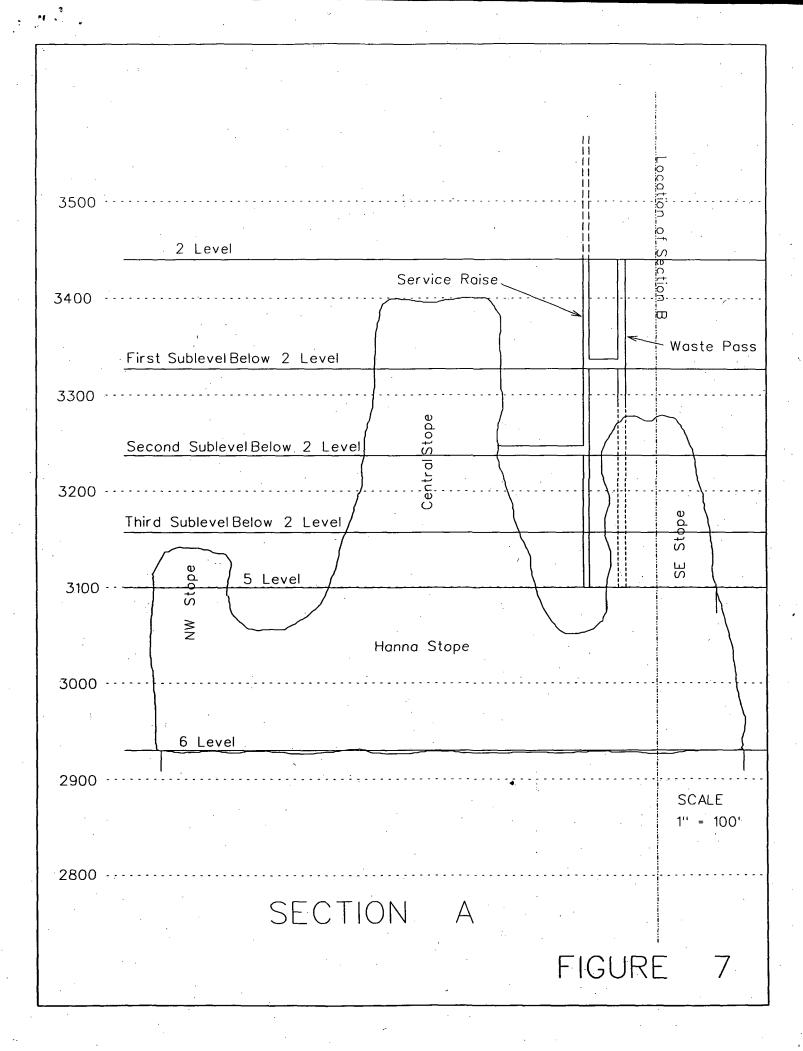
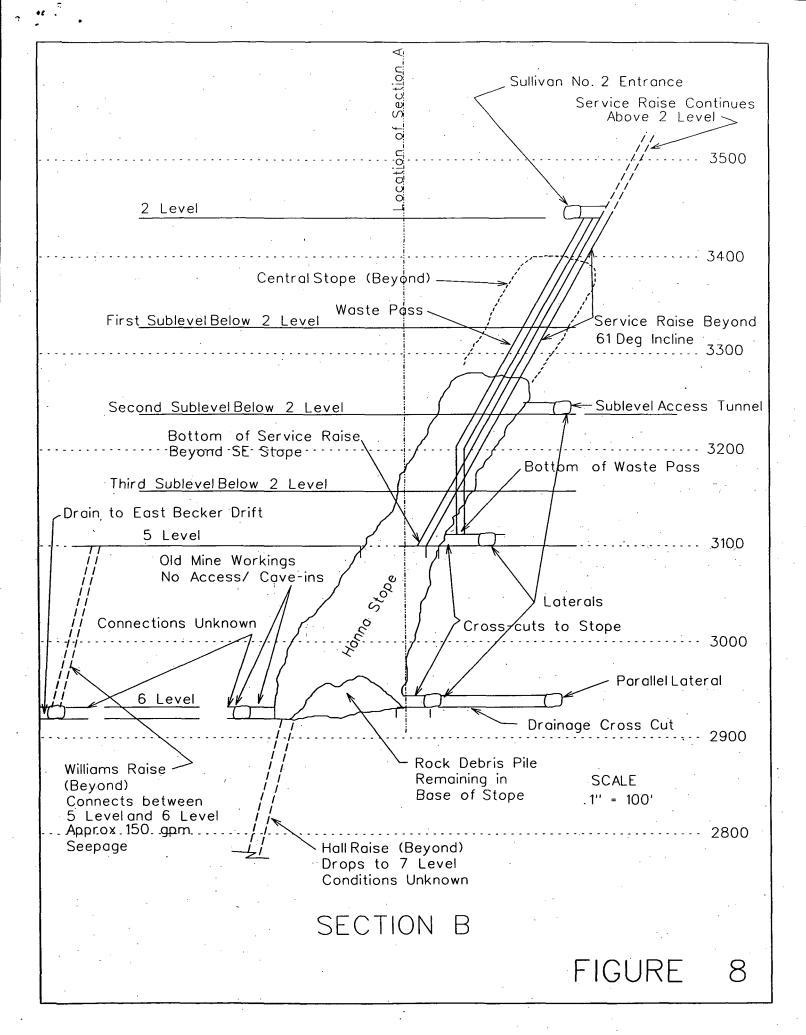
At Level 5, another stope was observed about 150 feet in a northwestern direction from the southeast stope (see central stope, as labeled on Figure 5). It is believed that all the stopes open up to a common cavity at the base near 6 Level, but that they were not connected at 5 Level (see Figure 7). The central stope area was found to be approximately 210 feet long and distance shots indicated the width to be about 65 feet. This stope also opened both upward and downward from the 5 Level access points. The natural rock quality was excellent in this area and relatively little water was found to be entering the stope from 5 Level or within the stope area. It is believed that other stopes may exist farther to the northwest, but the size or dimensions of these areas was not observed at 5 Level.

After leaving 6 Level, we returned along the same routes to 5 Level. At 5 Level, we ascended back up to 2 Level via the service raise near the southeast end of the stope area. While climbing back up the ladder, we estimated the vertical distance between the various sublevels below 2 Level as shown on Figures 7 and 8. We did not
